A Glossary of Historic Masonry Deterioration Problems and Preservation Treatments

Compiled by Anne E. Grimmer

Department of the Interior
National Park Service
Preservation Assistance Division

1984

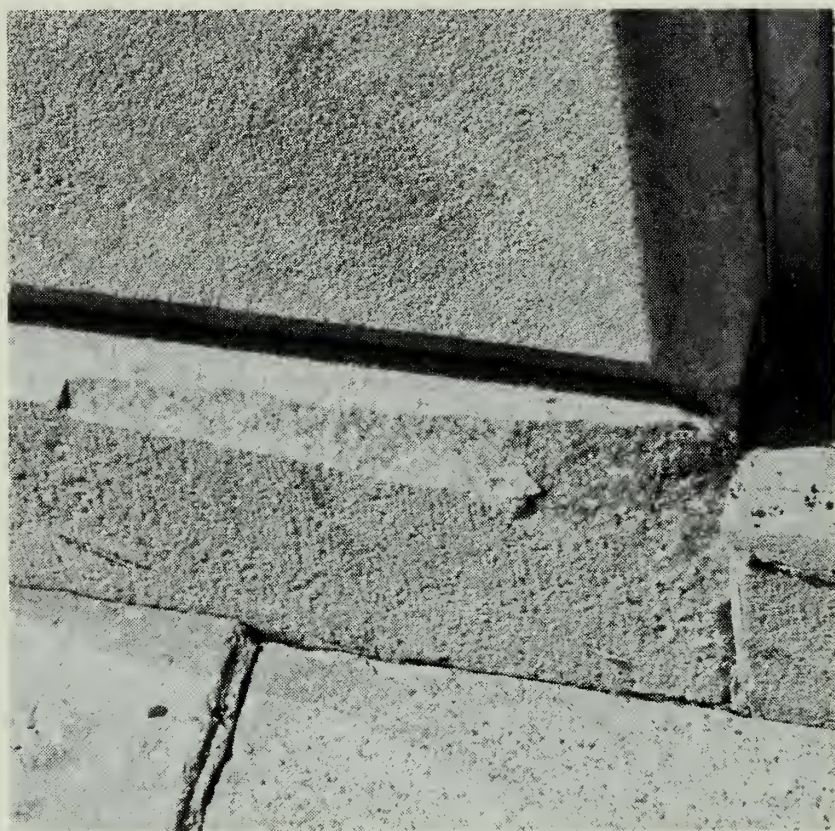
Small pieces or larger fragments of masonry separating from the masonry unit, often at corners or mortar joints. This may be the result of damage caused by later alterations or repairs, such as use of too hard a mortar, or by accident or through vandalism.

Chipping of granite sill. Photograph: Anne E. Grimmer.

Preservation Treatment: See Dutchman Repair, p.56; Replacement/Patching with Like or Compatible Substitute Materials, p.59.

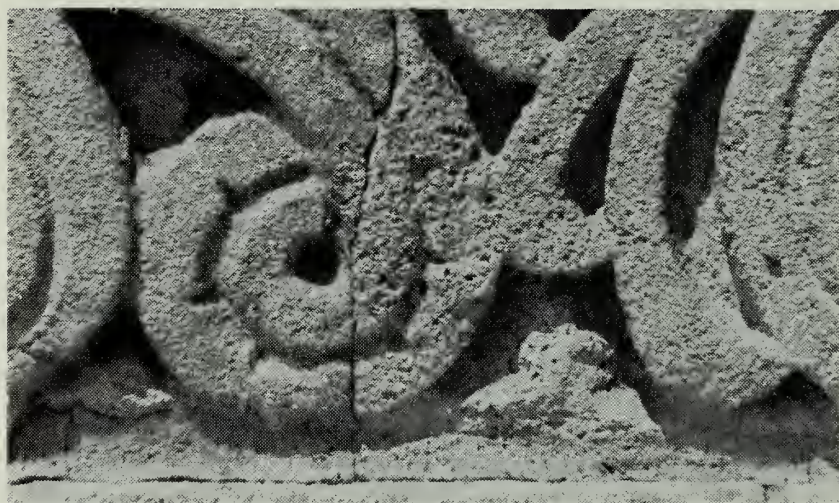
A term describing narrow fissures from 1/16 to 1/2 inch wide in a block of masonry. Cracking may result from a variety of conditions, such as structural settlement of a building, too hard a repointing mortar, or it may be an inherent characteristic of the masonry itself, such as unfired brick or adobe. Small cracks within a single block of masonry may not be serious, but longer and wider cracks extending over a larger area may be indicative of structural problems, and should be monitored.

Cracking of limestone. Photograph: John H. Myers.

Preservation Treatment: See Mechanical Repair, p.58; Replacement/Patching with Like or Compatible Substitute Materials, p.59.

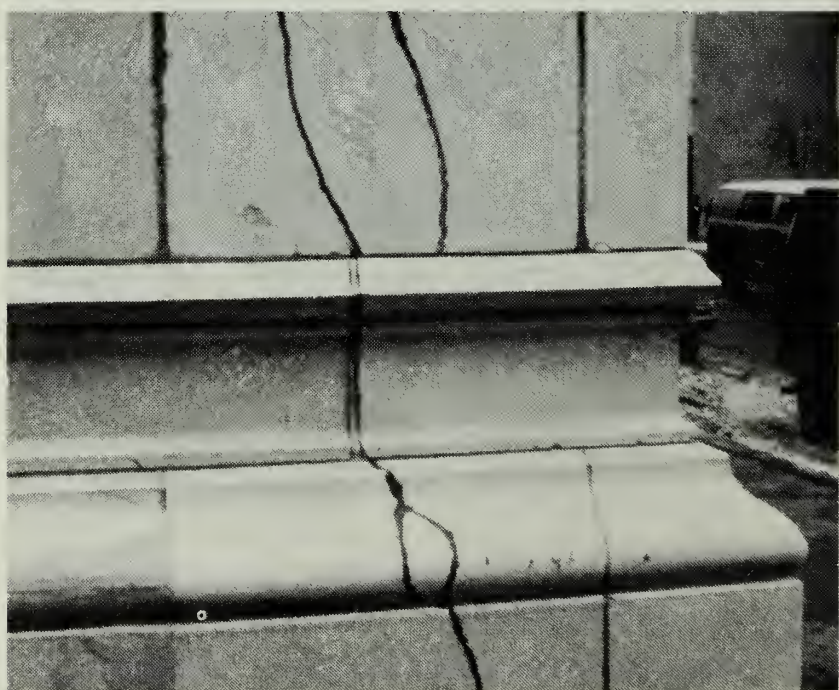
Cracking of glazed terra cotta. Photograph: National Park Service.

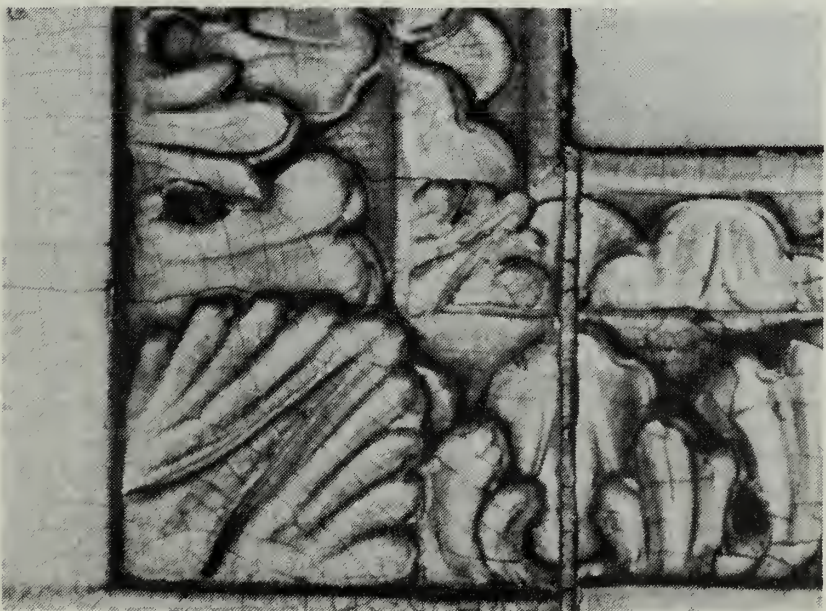
The formation of a pattern of tiny cracks or crackles in the glaze of glazed terra cotta. Crazing (dunting as it is called when it occurs immediately after the firing process and is caused by too rapid cooling) may develop over time as the terra cotta is exposed to the weather. When a terra cotta unit first comes from the kiln after firing, it has dried to its smallest possible size. With the passage of time it expands as it absorbs moisture from the air. The glaze then goes into tension because it has a lesser capacity for expansion than the porous tile body; it no longer "fits" the expanding unit onto which it was originally fired. If the strength of the glaze is exceeded by this expansion, the glaze will crack or craze (sometimes called moisture crazing). Unless the cracks visibly extend into the porous tile body beneath the glaze, crazing should not be regarded as highly serious material failure. It does, however, tend to increase the water absorption capability of the glazed terra cotta unit.

Crazing of glazed terra cotta. Photograph: National Park Service.

Preservation Treatment: To date, no completely effective treatment has been developed for this condition.

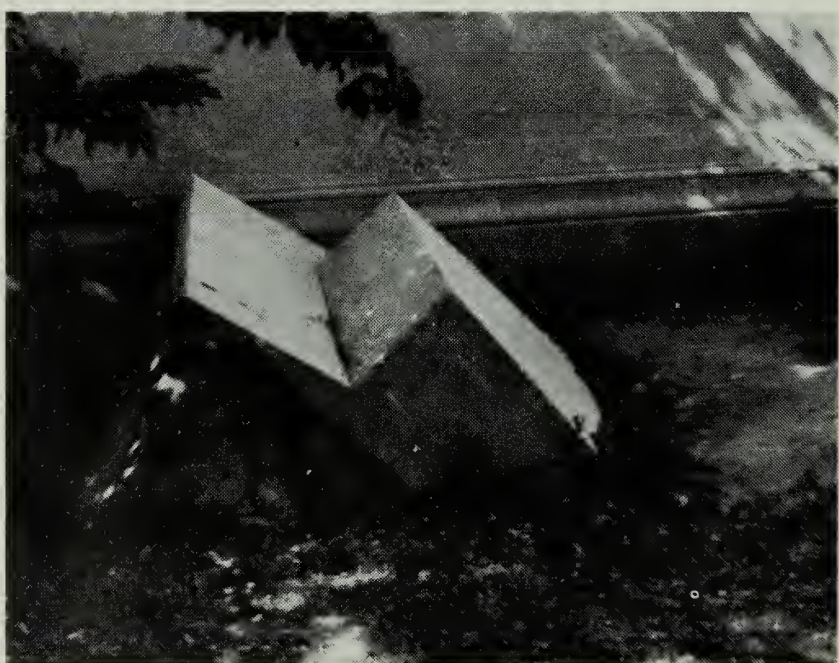
The result of a complete break (or failure of an original construction joint) in which the detached portion of masonry survives intact.

Detachment of section of marble pediment. Photograph: Walter Smalling.

Section of marble lying on the ground at base of building after it had separated from pediment above. Photograph: Walter Smalling.

Preservation Treatment: See Mechanical Repair, p.58.

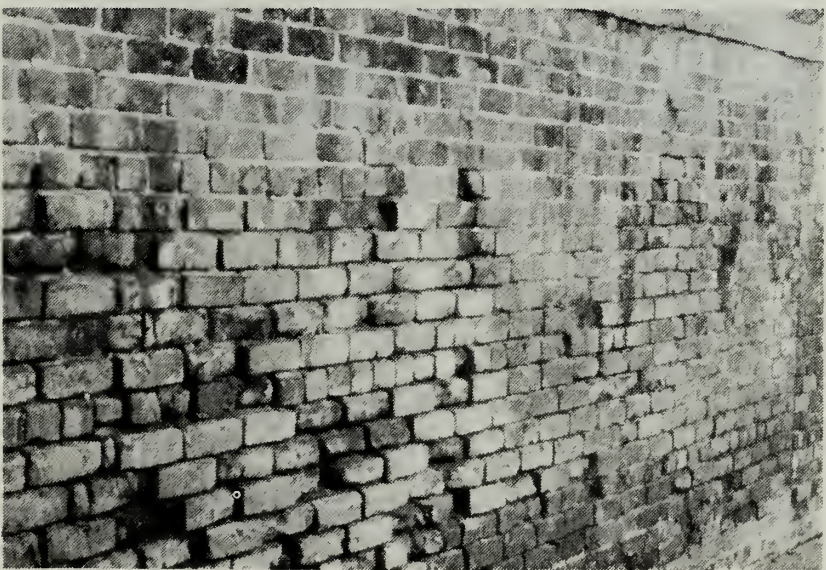
A whitish haze of soluble salts on masonry generally caused by excessive "pulling" of soluble salts into the masonry and out through the surface. Capillary action may pull soluble salts which result in efflorescence from the ground into the masonry, such as chlorides from salting of streets and sidewalks in winter and nitrates from fertilizers. In addition, carbonates from lime mortar and air-borne or water-deposited pollutants in the atmosphere may cause sulfates to be deposited on the surface of the masonry. Sulfates resulting from the curing and firing process are a common source of efflorescence in brick. Finally, efflorescence may be a combined salt residue left on the masonry surface by chemical cleaning, too strong a chemical solution, or improper rinsing.

Efflorescence and spalling on brick wall. Photograph: Anne E. Grimmer.

Preservation Treatment: See Poulticing, p.44; Water Washing, p.46.

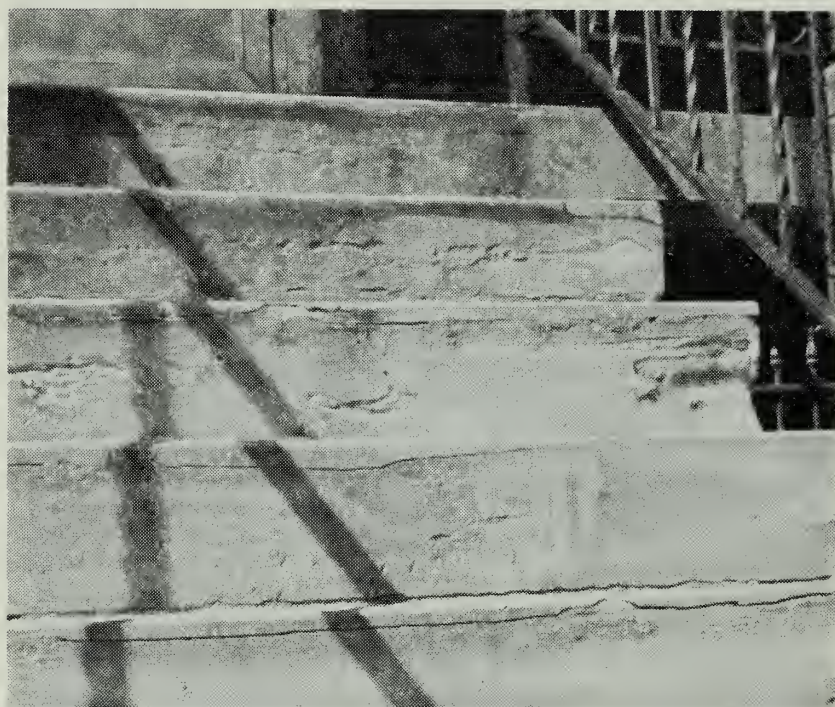
Wearing away of the surface, edges, corners or carved details of masonry slowly and usually by the natural action of wind or windblown particles and water. Erosion is one of the most serious kinds of adobe deterioration.

Differential erosion of sandstone steps follows bedding planes of greater and lesser resistance. Photograph: Anne E. Grimmer.

Preservation Treatment: See Replacement/Patching with Like or Compatible Substitute Materials, p.59.

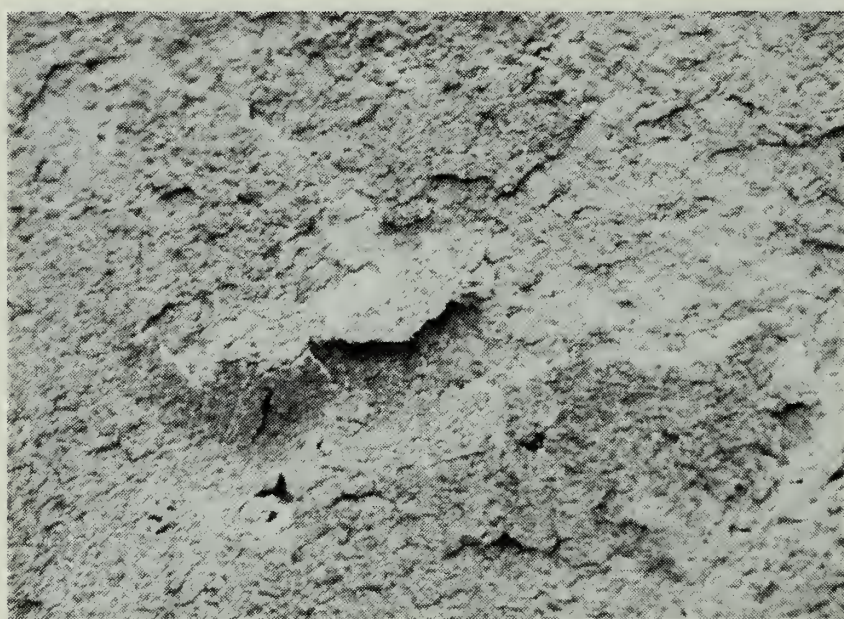
Flaking is an early stage of peeling, exfoliation, delamination or spalling, and is best explained as the detachment of small, flat, thin pieces of the outer layers of stone from a larger piece of building stone. Flaking is usually caused by capillary moisture or freeze-thaw cycles that occur within the masonry. The application of a water-repellent coating may result in flaking of the masonry when trapped moisture is forced to the surface.

Flaking of granite. Photograph: Baird M. Smith, AIA.

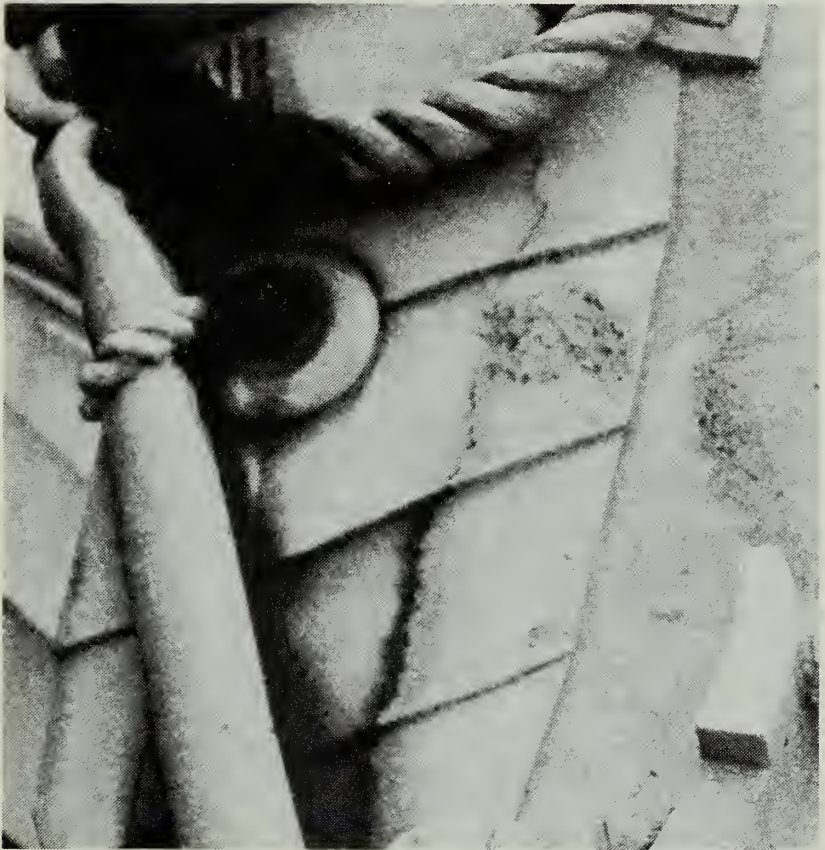
Friability in limestone. Photograph: Anne E. Grimmer.

Preservation Treatment: See Consolidation, p.52.

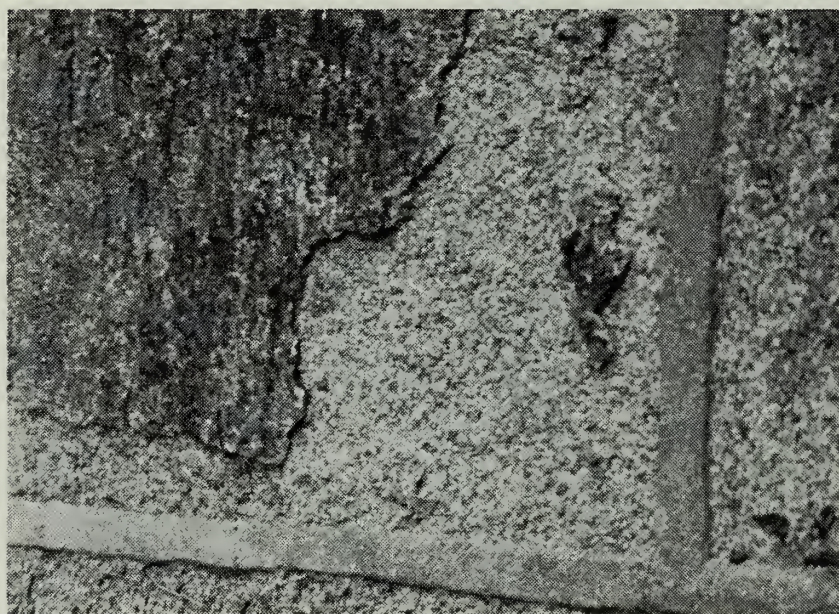
Peeling of stone may be caused by an inherent defect in the surface of the masonry or the result of weathering. Improper application of a masonry coating may result in a lack of adhesion to the substrate, and cause the surface of the masonry or coating to flake or peel away from the substrate in strips or layers.

Peeling of granite. Photograph: Baird M. Smith, AIA.

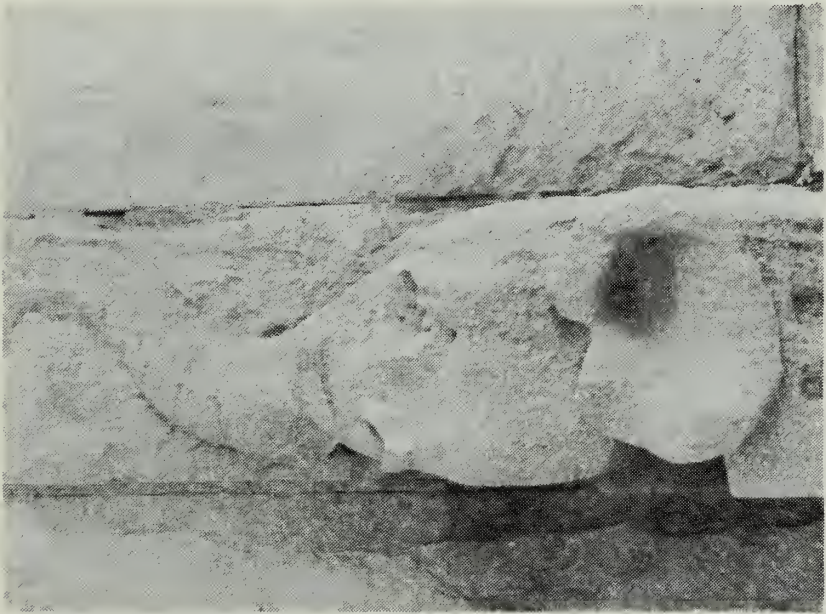
The development or existence of small cavities in a masonry surface which may be caused by the differential removal of individual components of the masonry and may be the result of natural weathering or erosion of an inherently porous type of masonry. Pitting may also result from a harsh or abrasive cleaning method. Pitting of concrete can be caused by improper mixing, and usually occurs during the curing period.

Pitting of limestone. Photograph: John H. Myers.

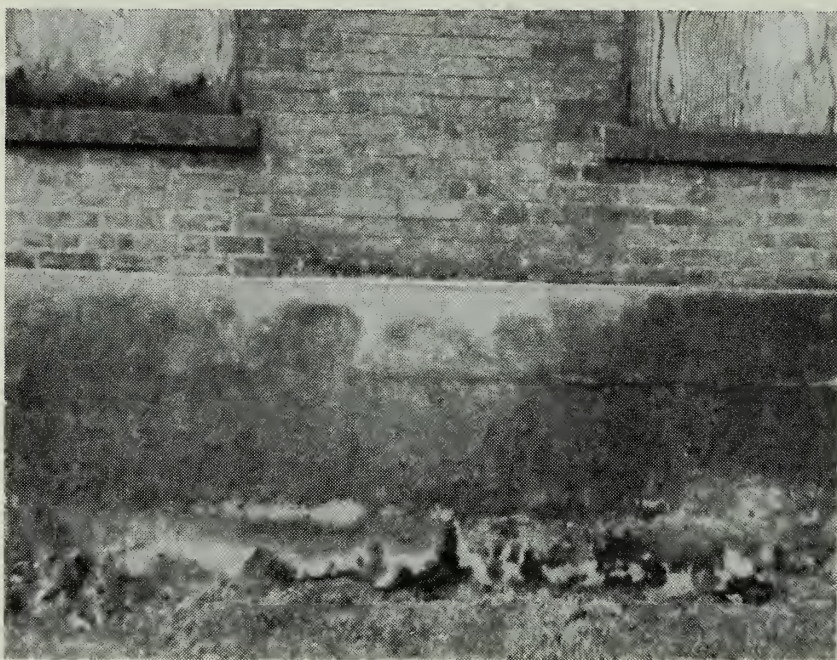
The suction of groundwater into the base of masonry walls through capillary action is called rising damp. Moisture is drawn up into the building walls and released at the interior and exterior surfaces where a horizontal wet stain or tidemark is left. The moisture often carries with it salts in solution, which can result in efflorescence and lead to deterioration of masonry, plaster, wood and paint. Rising damp, often the result of improper drainage, is a problem common to many older masonry structures, and one that is difficult to solve completely.

*Rising damp evidenced on parged foundation.
Photograph: John Stubbs.*

Preservation Treatment: See Dampproof Course, p.54.

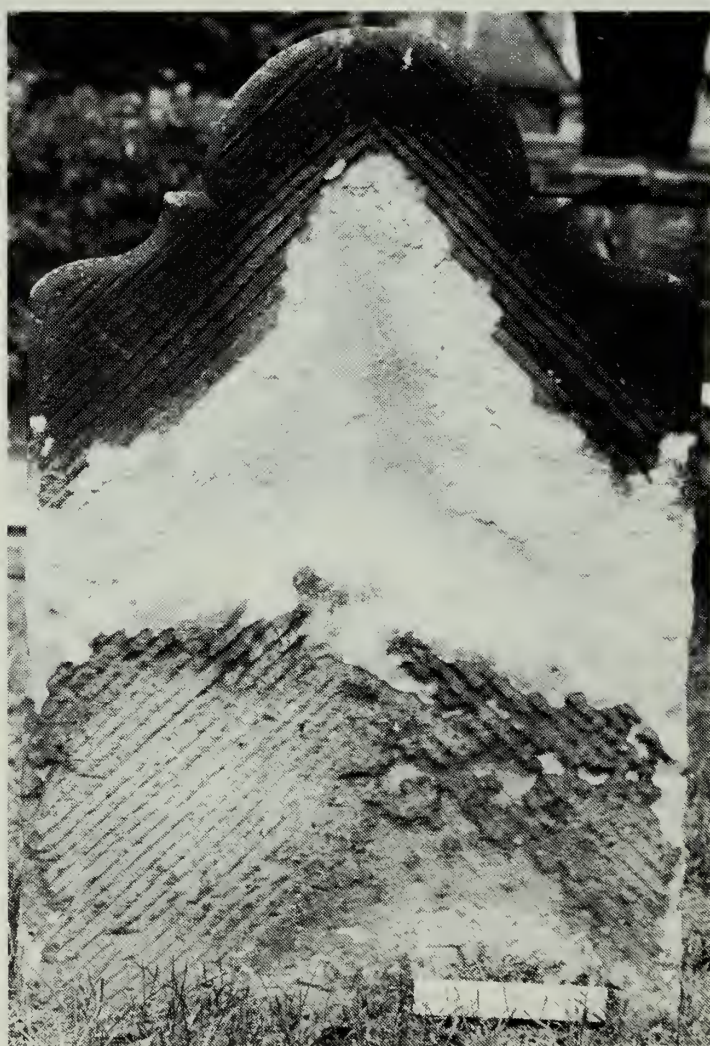
Surface crust on sandstone resulting from dissolution of the stone. Photograph: Erhard M. Winkler.

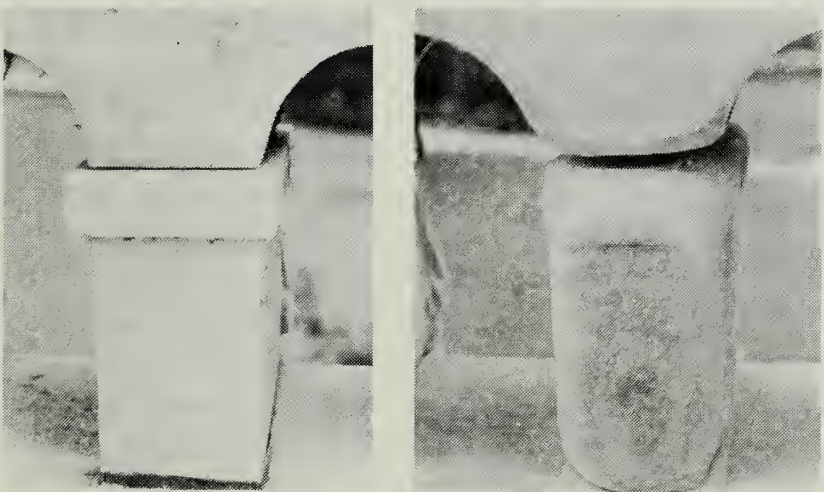
Weathering has reduced the formerly sharp edges and rounded the corners of this marble baluster. Photograph: John H. Myers.

Preservation Treatment: Replacement/Patching with Like or Compatible Substitute Materials, p.59.

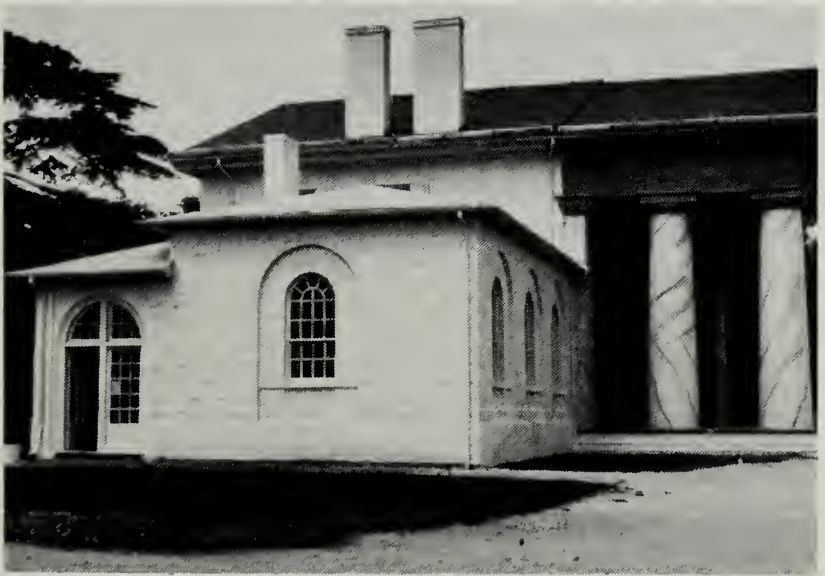
Paint applied to masonry may be solvent or water based, or may be a masonry paint of a slightly cementitious nature specially formulated with various types of aggregate or thickening agents to smooth rough or uneven masonry walls. Color washes based on lime, such as whitewash, although not technically considered to be paint, and color stains which do not form a film on top of the masonry, but instead penetrate into the masonry substrate, have traditionally provided many of the same benefits as paint.

Paint used as a purely decorative aspect to simulate marble on a stucco surface. Photograph: National Park Service.

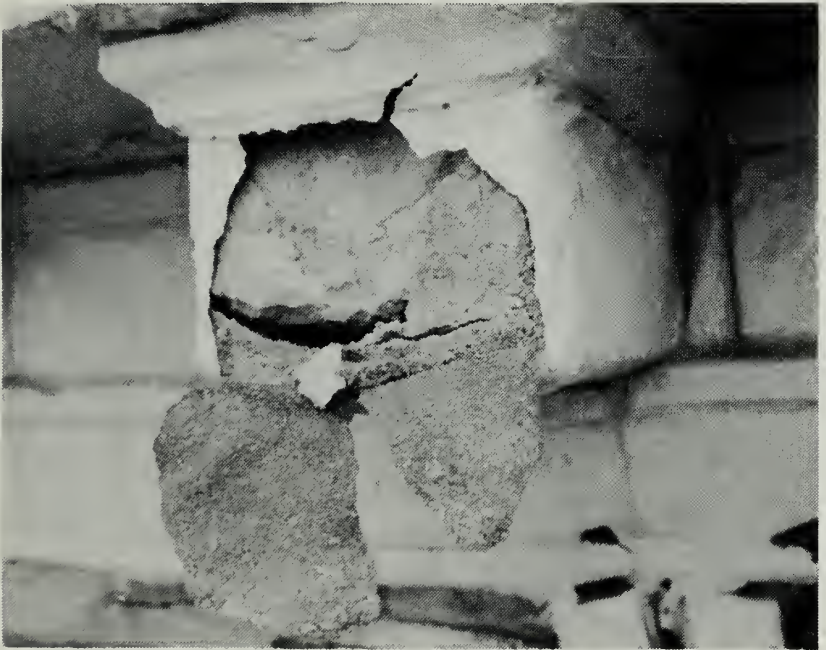
These coatings seal the masonry surface from both liquid water and water vapor; they may be clear or opaque—and include bituminous coatings such as those applied to building foundations, and also some paints. They generally do not cause problems as long as they exclude all water from masonry, but if water does enter the wall, the coating can intensify the damage to the wall because the water will not be able to escape. Basically, waterproof coatings make a surface *impervious* to water.

A neoprene coating over a limestone cornice has trapped water (which entered through leaks in the parapet) inside these stone dentils. The built-up water pressure has finally forced the coating to pop off, taking with it pieces of the stone. Photograph: National Park Service.

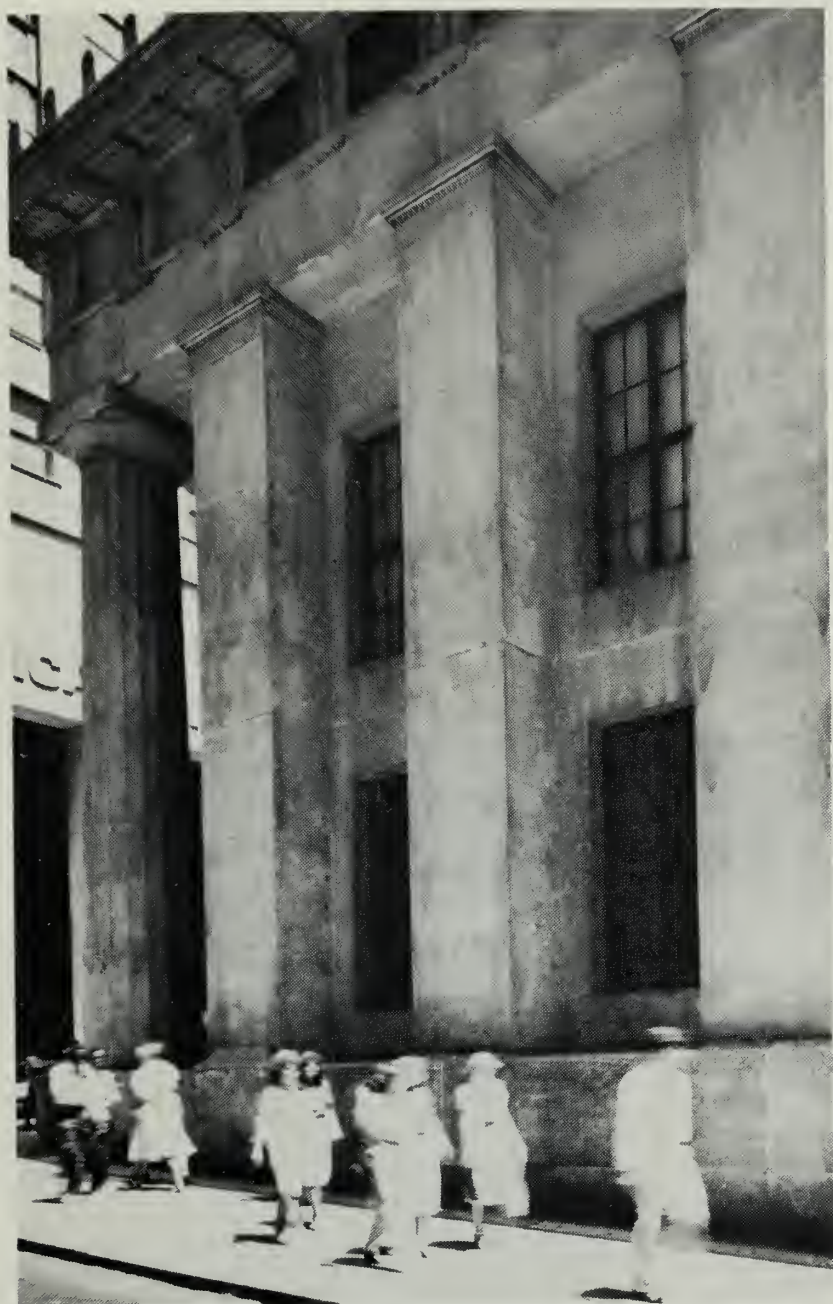
A water-repellent or waterproof coating should never be applied to an already damp or wet building which may be likely to have **sub-florescence** under its surface. Such a coating would further prevent the excessive moisture (and dissolved salts) within the wall from evaporating out through the walls, thereby almost ensuring that the walls retain the water and salts, and thus increasing the possibility of spalling.

Water-repellent coating improperly applied gives a blotchy appearance to the stonework. Photograph: Walter Smalling.

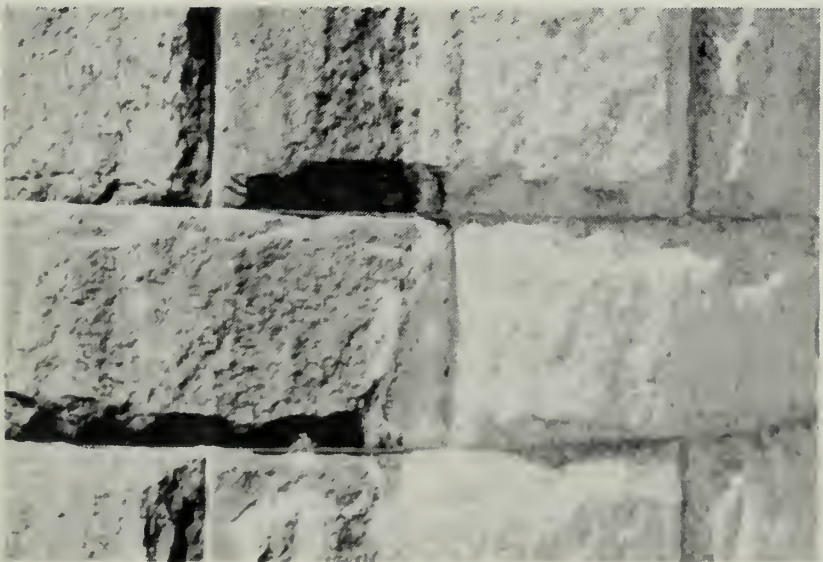
Although chemical cleaning is generally an acceptable technique for cleaning historic masonry buildings, and certainly the most effective and least damaging method of removing paint, if not carried out with adequate precautions, it can also be damaging to historic masonry. Some of the potential hazards of chemical cleaning include inappropriate or too strong a chemical solution, cleaning during cold weather or when there is a possibility of frost, insufficient rinsing of the masonry after application of the chemical mixture, and environmental or health hazards.

Chemical cleaning to remove urban dirt and pollution from granite without causing damage or abrasion to the surface of the stone.

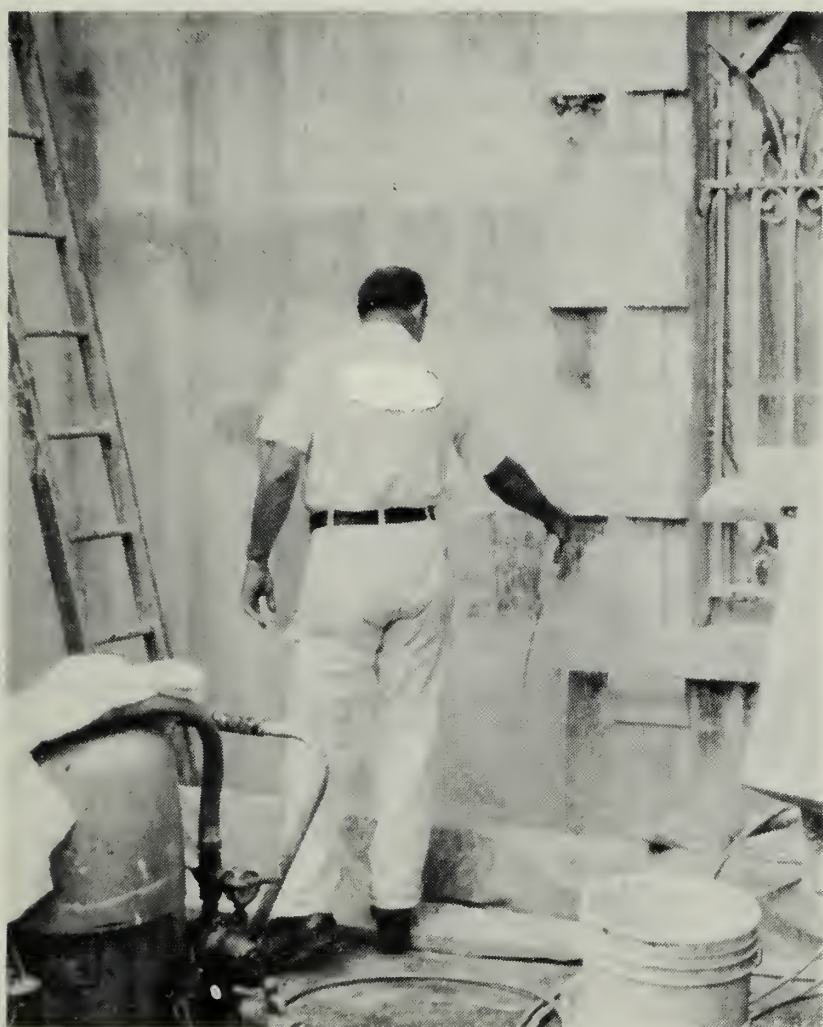
Paint removal from sandstone. Photograph: Baird M. Smith, AIA.

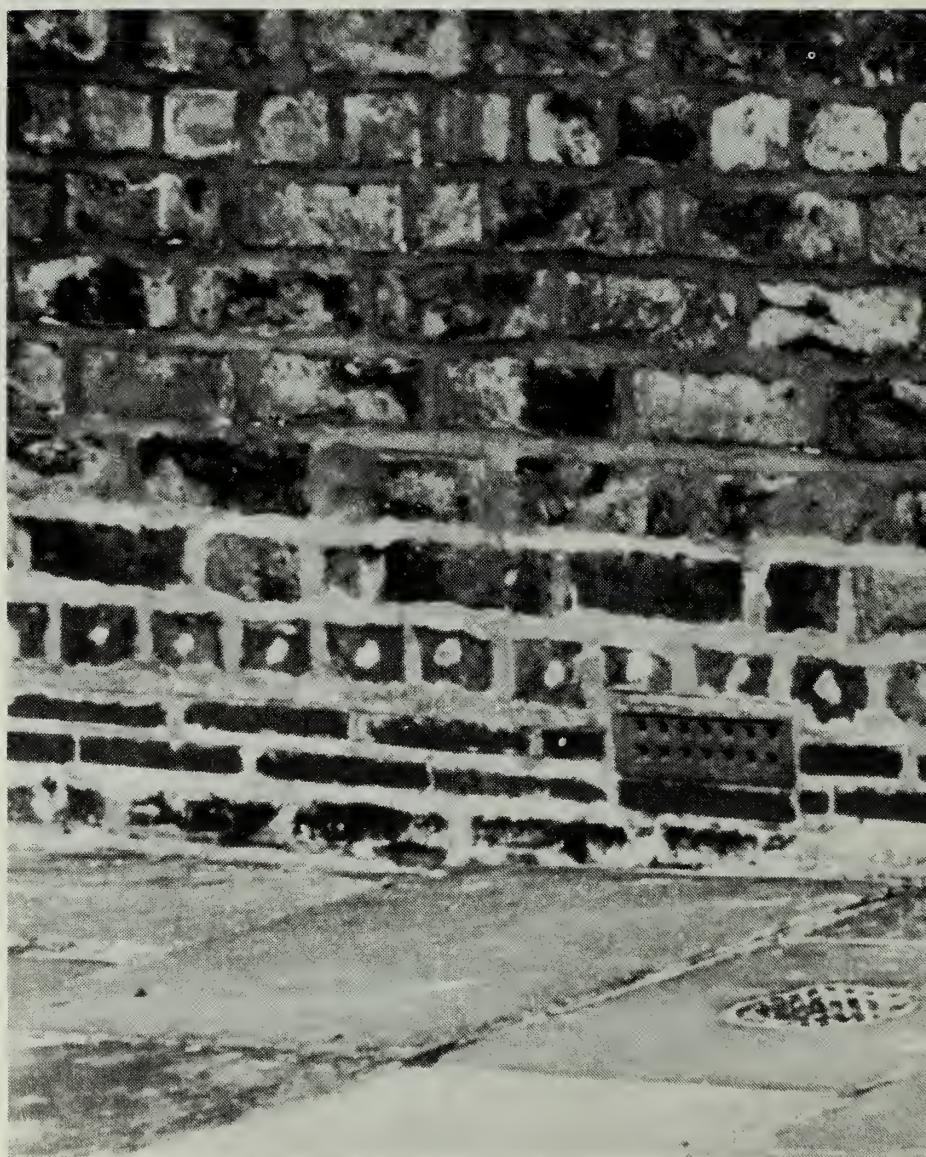
Installation in masonry of a horizontal layer of material which is impervious to water, such as tile, slate, lead-cored bituminous sheet or bituminized felt, polyethylene sheeting, or metal, to prevent the capillary rise of moisture—**rising damp**—from the ground into the masonry wall. Historically, some masonry buildings were constructed with a dampproof course, but usually dampproof courses must be added later as a remedial measure to correct problems caused by rising damp. A traditional dampproof course is not installed without difficulty, as a continuous horizontal course must be cut out of the mortar or brick at a level just above the ground and below first floor joists, and the dampproofing material inserted in an uninterrupted horizontal course. This system

The horizontal row of white dots in the brick headers indicates that a chemical dampproof course has been injected. Photograph: Baird M. Smith, AIA.
